New Hampshire Volunteer Lake Assessment Program

2002 Bi-Annual Report for Gumpas Pond Pelham

NHDES Water Division Watershed Management Bureau 6 Hazen Drive Concord, NH 03301

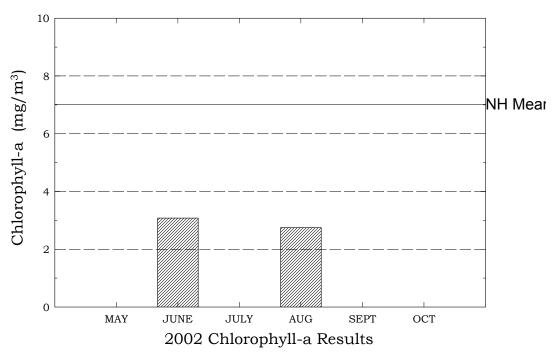
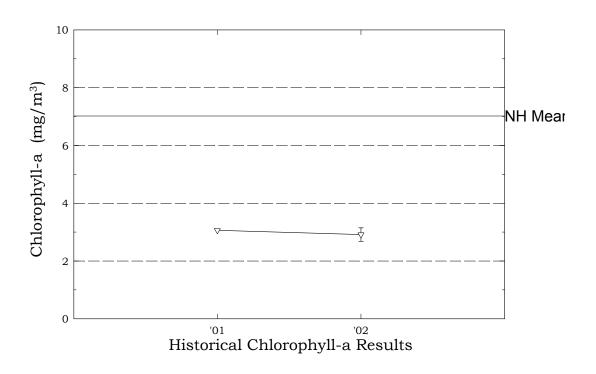
Figure 1. Monthly and Historical Chlorophyll-a Results

Figure 1 and Table 1: The graphs in Figure 1 (Appendix A) show the historical and current year chlorophyll-a concentration in the water column. Table 1 (Appendix B) lists the maximum, minimum, and mean concentration for each sampling season that the lake/pond has been monitored through the program.

The current year data (the top graph) show that the chlorophyll-a concentration *decreased* from June to August.

The historical data (the bottom graph) show that the 2002 chlorophyll-a mean is *less than* the state mean.

Overall, visual inspection of the historical data trend line (the bottom graph) shows **a stable** in-lake chlorophyll-a trend, meaning that the concentration has **remained approximately the same** since monitoring began in 2001. Please note that this trend is based on only two years of data. After 10 consecutive years of sample collection, we will be able to conduct a statistical analysis of the historic data to objectively determine if there has been a significant change in the annual mean chlorophyll-a concentration since monitoring began.

While algae are naturally present in all lakes/ponds, an excessive or increasing amount of any type is not welcomed. In freshwater lakes/ponds, phosphorus is the nutrient that algae depend upon for growth. Therefore, algal concentrations may increase when there is an increase in nonpoint sources of nutrient loading from the watershed, or in-lake sources of phosphorus loading (such as phosphorus releases from the sediments). It is important to continually educate residents about how activities within the watershed can affect phosphorus loading and lake quality.

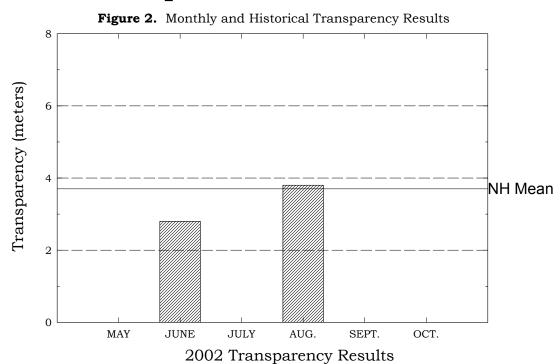
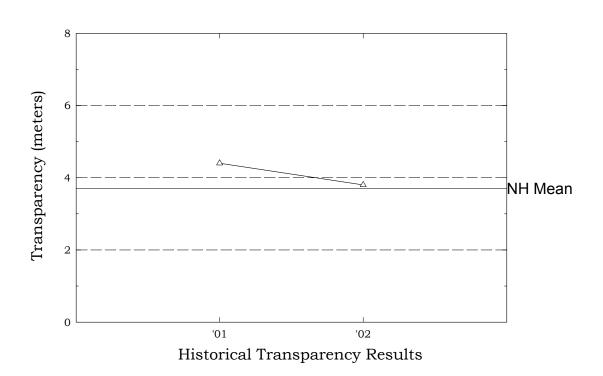
Figure 2 and Table 3: The graphs in Figure 2 (Appendix A) show historical and current year data for lake/pond transparency. Table 3 lists the maximum, minimum and mean transparency data for each sampling season that the lake/pond has been monitored through the program.

The current year data (the top graph) show that the in-lake transparency *increased* from June to August. The transparency in August was *slightly greater than* the state mean.

The historical data (the bottom graph) show that the 2002 mean transparency is *approximately equal to* the state mean.

Typically, high intensity rainfall causes erosion of sediments into lakes/ponds and streams, thus decreasing clarity. Efforts should continually be made to stabilize stream banks, lake/pond shorelines, disturbed soils within the watershed, and especially dirt roads located immediately adjacent to the edge of tributaries and the lake/pond. Guides to Best Management Practices designed to reduce, and possibly even eliminate, nonpoint source pollutants, such as sediment loading, are available from NHDES upon request.

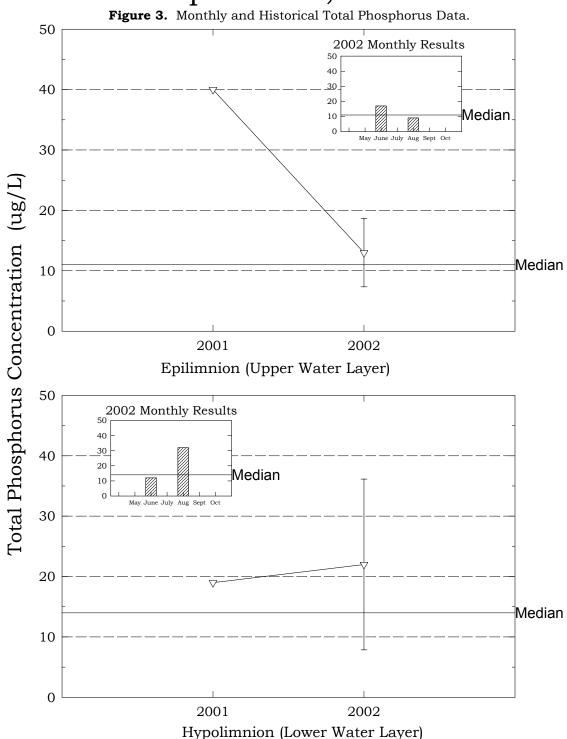
Figure 3 and Table 8: The graphs in Figure 3 (Appendix A) show the amounts of phosphorus in the epilimnion (the upper layer) and the hypolimnion (the lower layer); the inset graphs show current year data. Table 8 (Appendix B) lists the annual maximum, minimum, and median concentration for each deep spot layer and each tributary since the lake/pond has joined the program.

The current year data for the epilimnion (the top inset graph) show that the total phosphorus concentration **decreased** from June to August. The total phosphorus concentration in June was **greater than** the state median.

The historical data show that the 2002 mean epilimnetic total phosphorus concentration is **slightly greater than** the state median.

The current year data for the hypolimnion (the bottom inset graph) show that the total phosphorus concentration *increased greatly* from June to August. The total phosphorus concentration in August was *much greater than* the state median.

The historical data show that the 2002 mean hypolimnetic total phosphorus concentration is *greater than* the state median.

However, it is important to note that the total phosphorus concentration in the hypolimnion sample on the **August** sampling date was elevated. In addition, the turbidity of the hypolimnion sample was elevated. The laboratory staff also noted that sediment was observed in the hypolimnion sample bottle. This suggests that the lake/pond bottom may have been disturbed by the anchor or by the Kemmerer Bottle while sampling. When the lake/pond bottom is disturbed, sediment, which typically contains attached phosphorus, is released into the water column. When collecting the hypolimnion sample, please check to make sure that there is no sediment in the Kemmerer Bottle before filling the sample bottles.

Overall, visual inspection of the historical data trend line for the epilimnion show **a** decreasing total phosphorus trend, which means that the concentration has **improved** in the epilimnion since monitoring began.

Overall, visual inspection of the historical data trend line for the hypolimnion shows **a slightly increasing** total phosphorus trend, which means that the concentration has **slightly worsened** in the hypolimnion since monitoring began.

One of the most important approaches to reducing phosphorus loading to a waterbody is to continually educate watershed residents about its sources and how excessive amounts can adversely impact the ecology and value of lakes and ponds. Phosphorus sources within a lake or pond's watershed typically include septic systems, animal waste, lawn fertilizer, road and construction erosion, and natural wetlands. If you would like to educate watershed residents about
